Subject: After-Field Summary Letter Report, Biological Surveys of San Diego County (SDC) Wall Prototype, San Diego County, California, Task Order HSBP1017F00134, Work Order 01

SDC Prototype Wall Construction Biological Resources Survey, After-Field Report Photo
Pages

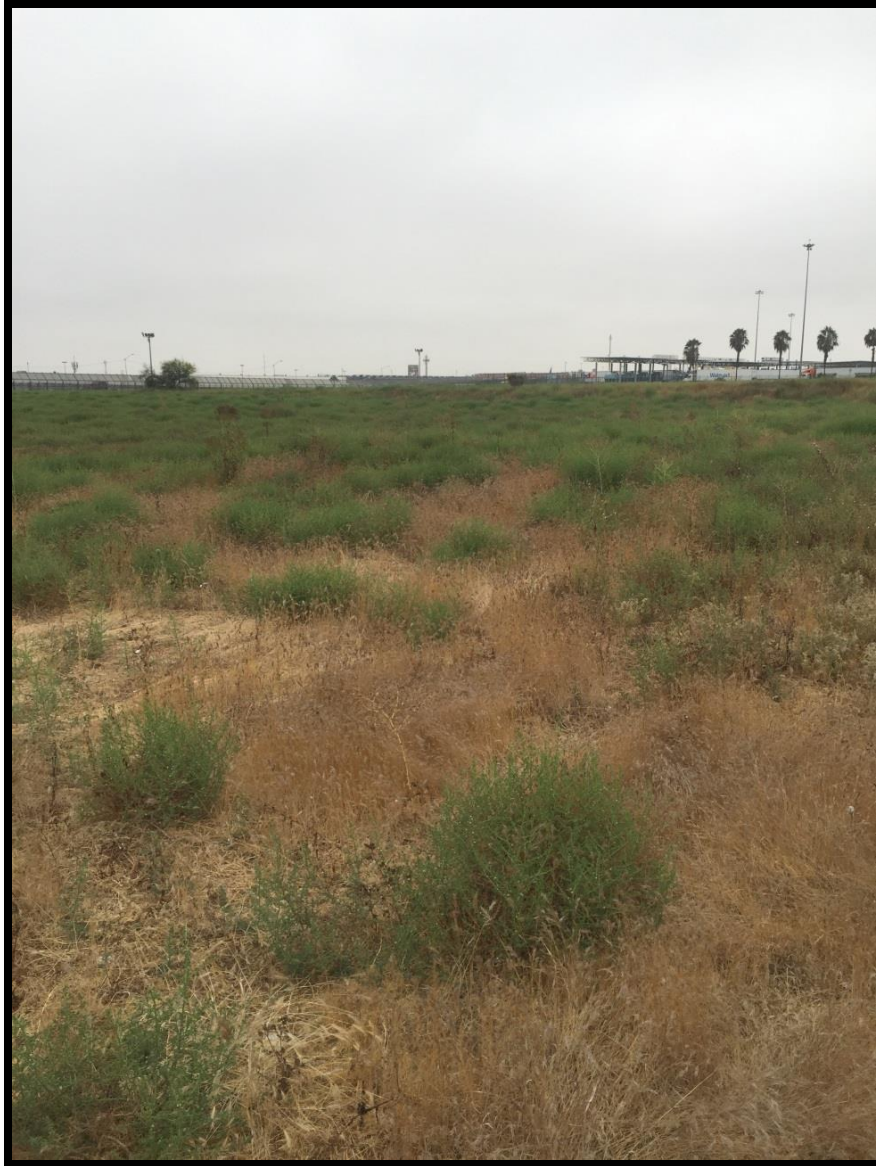
Photograph 1. This image depicts the heavily disturbed landscape within the entry and potential staging area, dominated by non-native species; (looking southwest from northeast corner).

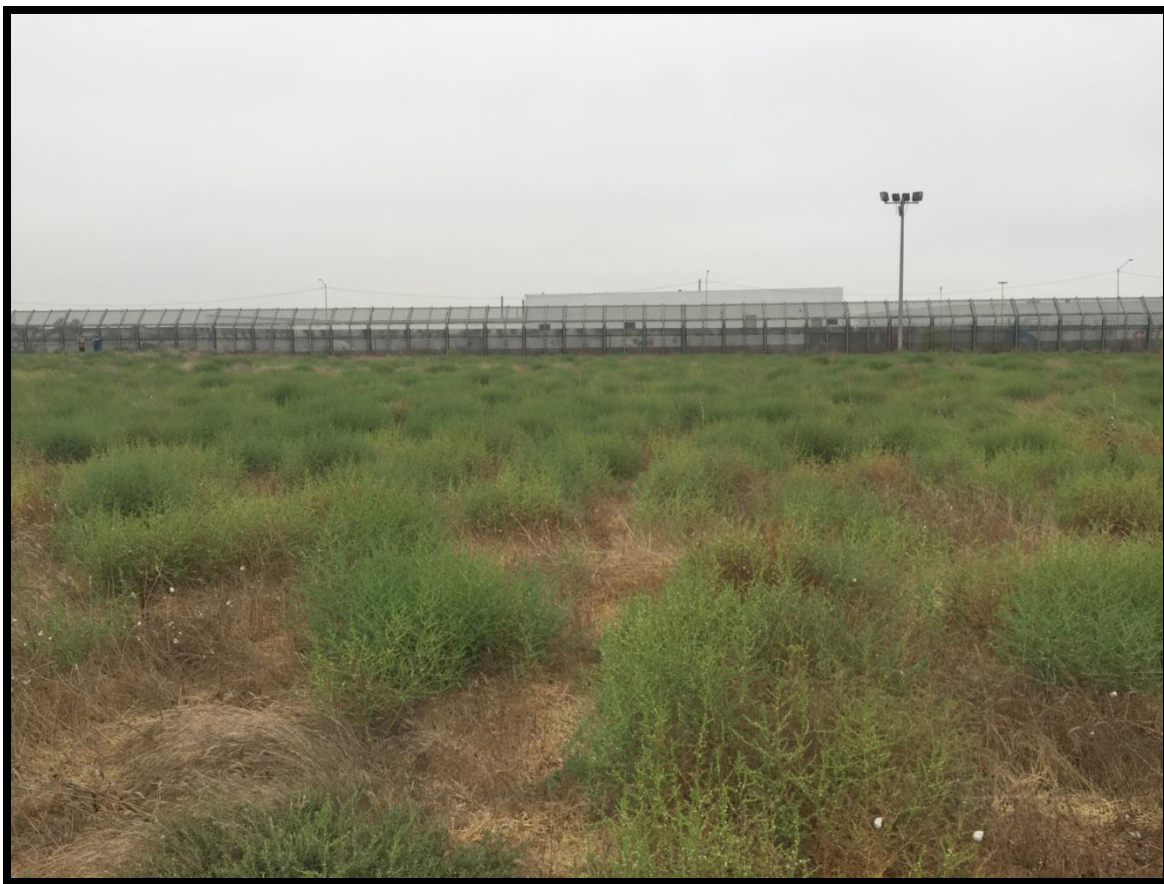
Photograph 2. This image depicts the heavily disturbed landscape within the entry and potential staging area, dominated by non-native species (looking south from an approximate center of survey area).

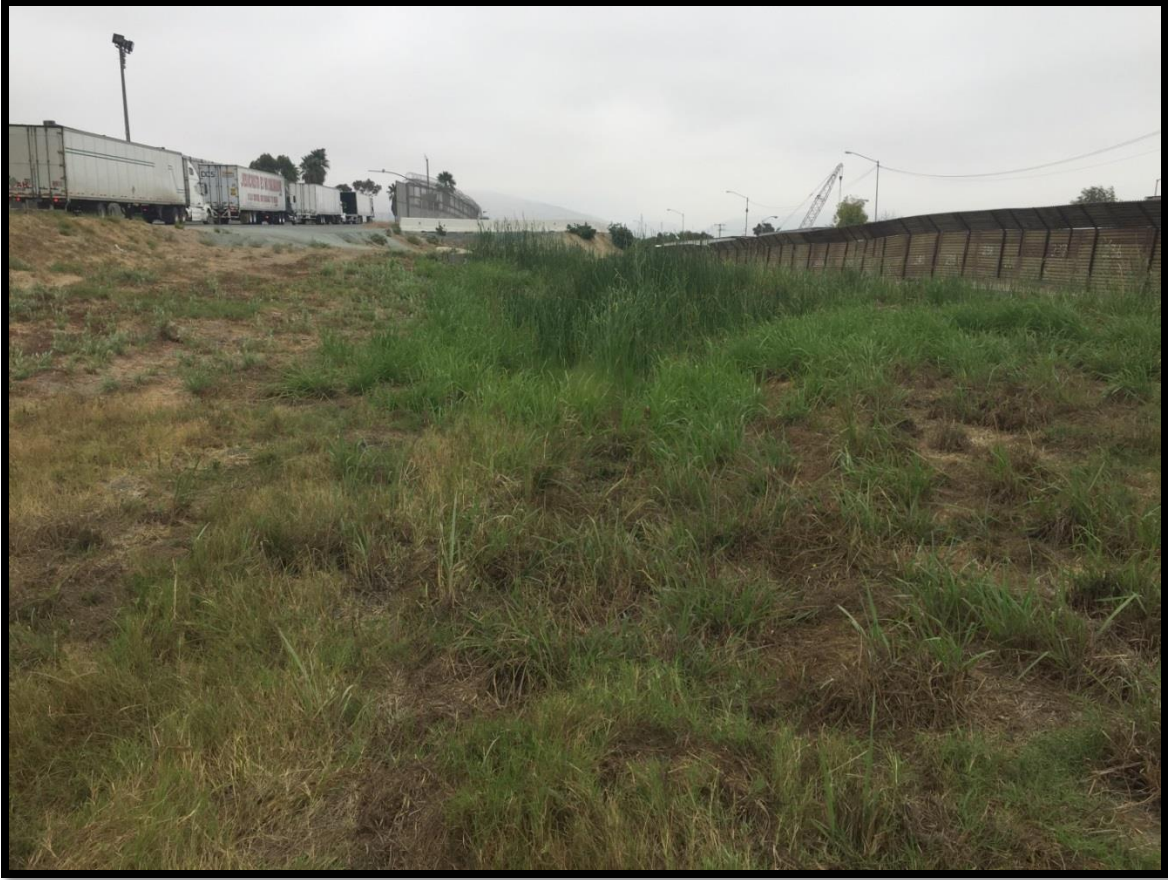
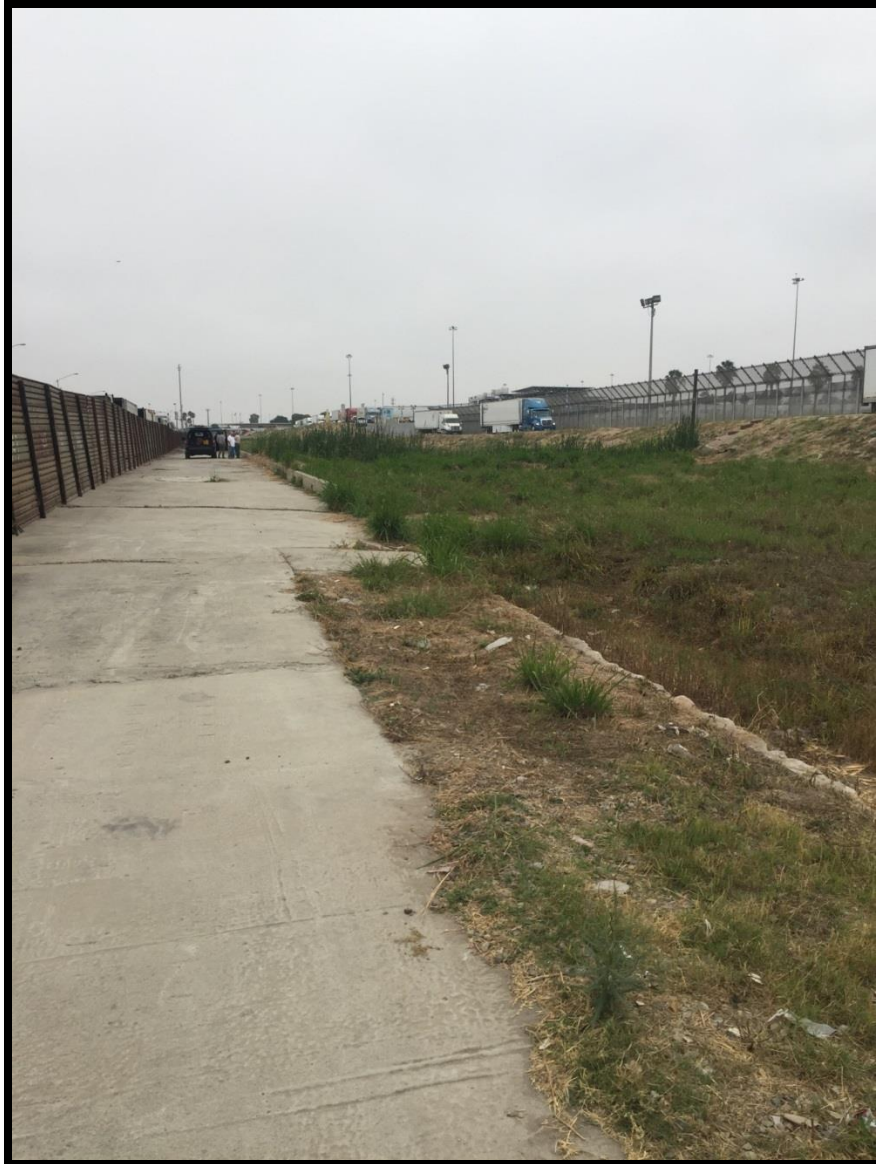
A shallow ditch within the enforcement zone to the east of the entry and potential staging area displayed vegetation and hydrology consistent with wetlands and should be considered as potential wetland habitat (Attachment B, Map 1), (Attachment C, Photographs 3 and 4).

The GSRC biologists identified a potential wetland area south of the entry and potential staging area within the border enforcement zone. This area should be avoided during construction activities.

Photograph 3. This image depicts the potential wetland immediately south of the entry and potential staging area (looking east from eastern end of project corridor).

Photograph 4. This image depicts the potential wetland immediately south of the entry and potential staging area (looking west towards the project terminus).

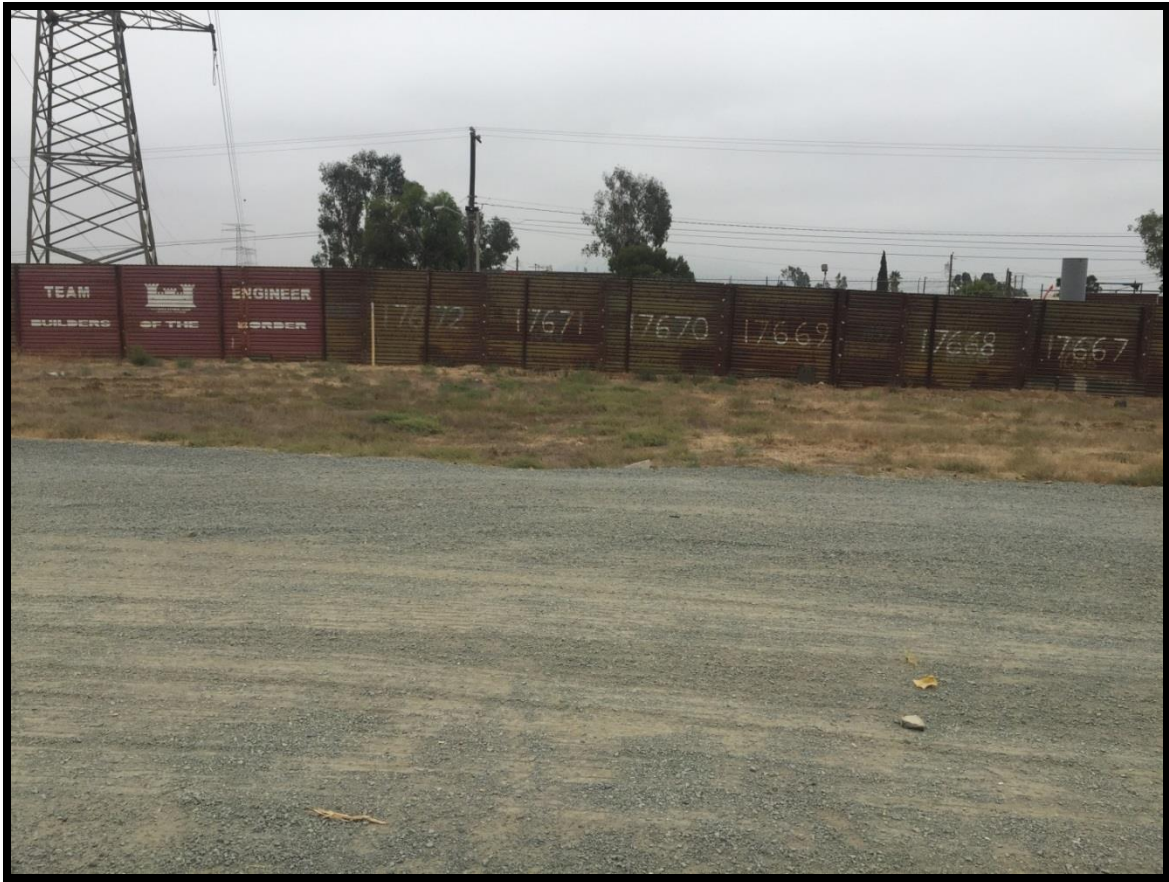
Photograph 9. This image depicts the typical level of disturbance and conditions within the border enforcement zone survey area (looking south).

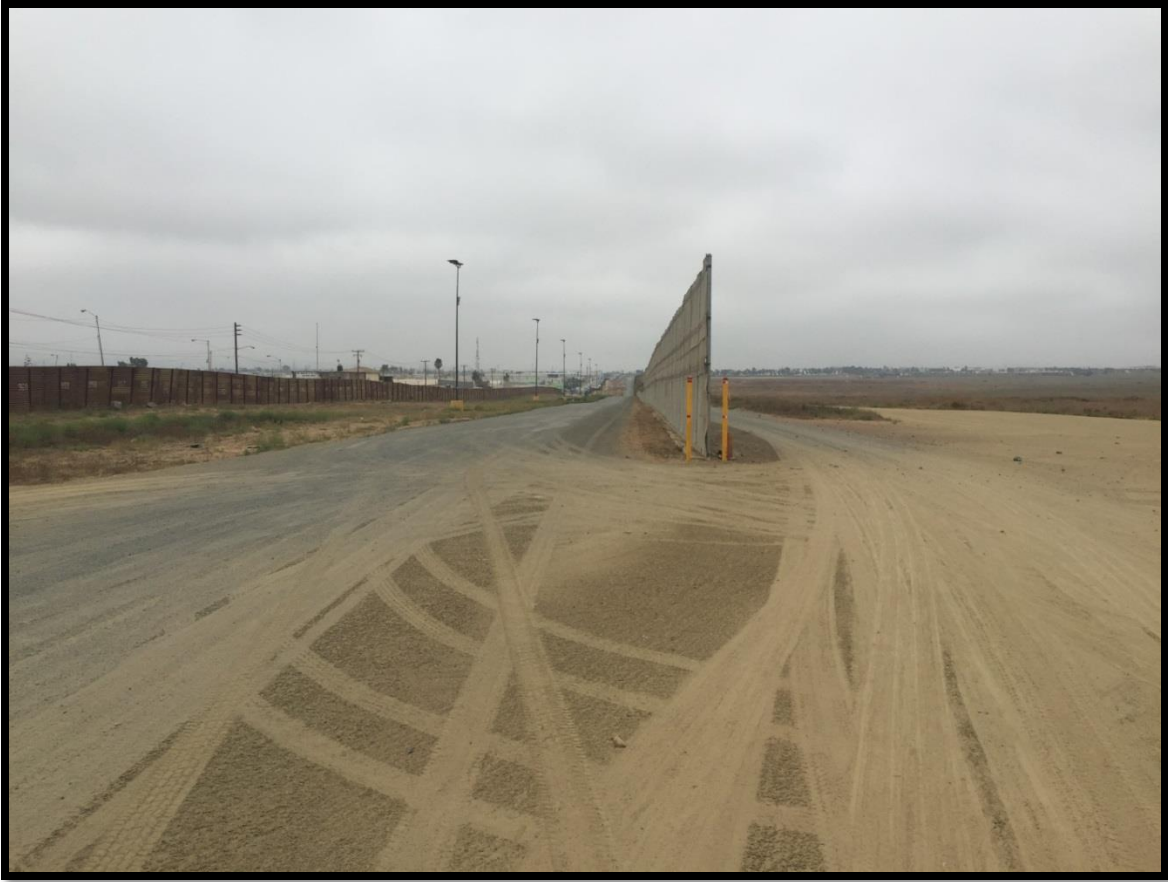
Photograph 10. This image depicts the typical level of disturbance and conditions within the enforcement zone survey area (looking west from the eastern end of the project area).

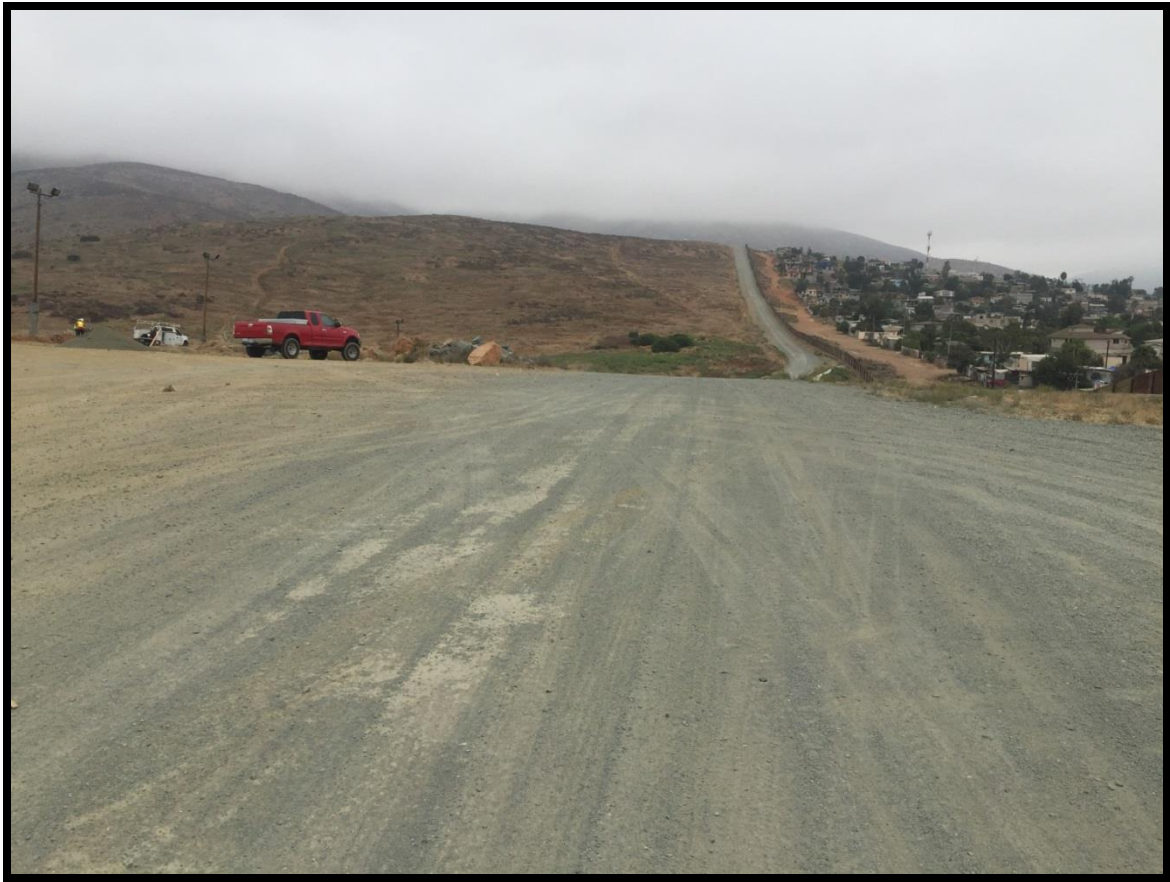
Photograph 12. This image depicts the typical level of disturbance and conditions within the prototype construction survey area (looking east from the eastern end of the secondary fence).

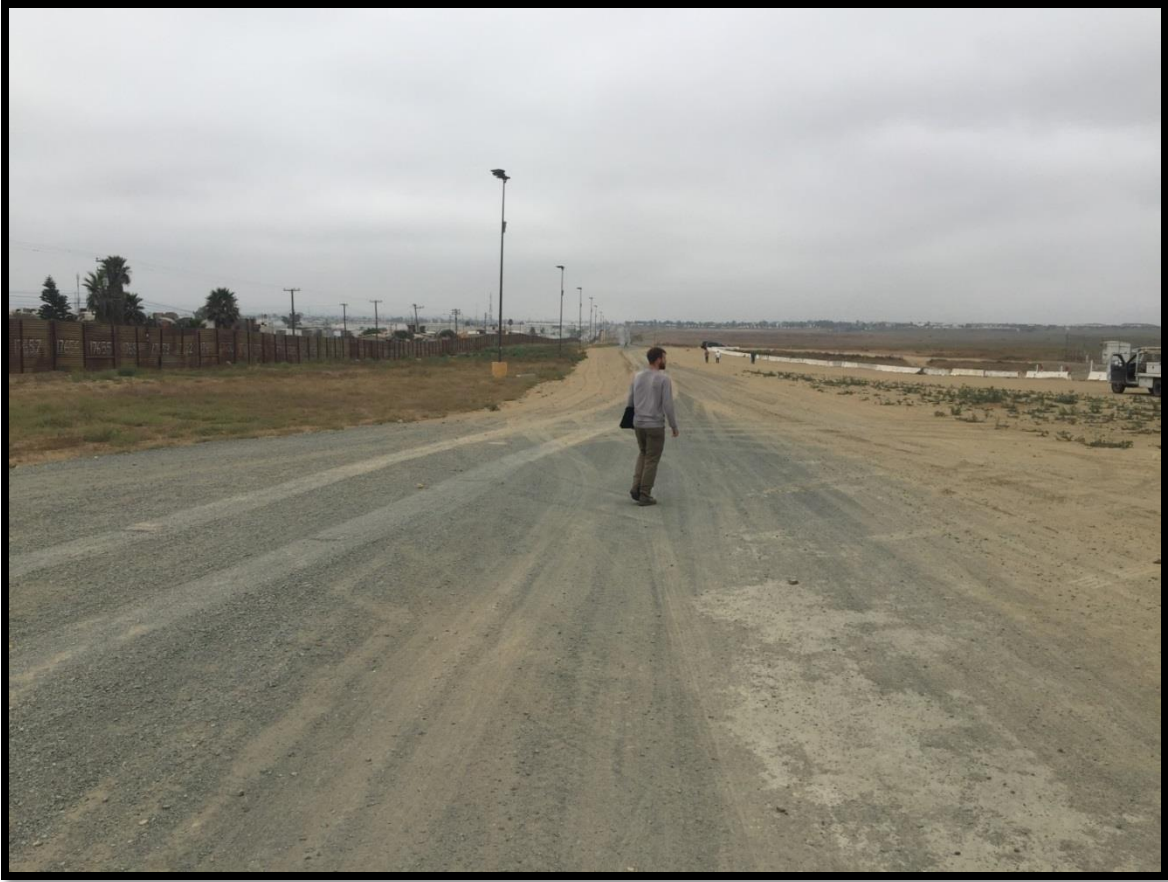
Photograph 13. This image depicts the typical level of disturbance and conditions within the prototype construction survey area (looking west from the eastern end of project area).
